BAIYUN
Brake Expert

BRAKE LINING TROUBLE TRACER

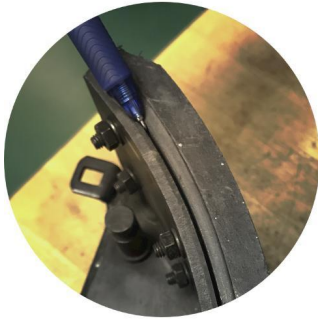
Build up dirt between lining and brake shoe

- Shoe radius out of line
- Shoe platform not blast cleaned and painted properly
- Shoe platform not parallel
- Lining riveted incorrectly

- Cracks in the lining material or crack in drum surface
- Loose linings
- Squeal and noise
- Improper cleaning causes rust scale to build up and lift the lining from the shoe

Replace linings and ensure shoe is clean and free from contamination before lining fitment

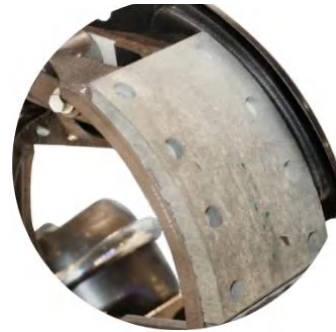
Poor bedding of friction material

- Drum diameter is larger than lining radius
- Bedding-in period for the lining was too short
- Drum wear

- If the wear pattern differs across the axle, vehicle pull can result; also excessive brake noise
- Low deceleration
- Either low or very high deceleration, with high deceleration the linings may lock on to the drum
- If the wear pattern differs across the axle, vehicle pull and excessive noise can result

Replace linings and ensure the correct lining radius to drum diameter is selected, or extend bedding-in period

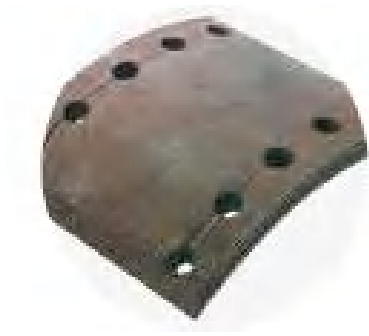
Deep irregular circumferential grooves on the brake lining

- Large particles loose in the brake
- Very poor drum condition and maintenance

- Lining wear out quickly
- Squeal and noise

Avoid contamination. Replace linings and grind or replace drum as appropriate

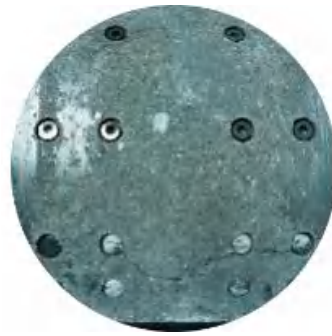
Grooves on the brake lining surface

- Small loose particles in the brake
- Insufficient drum cleaning at replacement

- Lining wear out quickly
- Squeal and noise

Replace linings and avoid brake operation in dusty environment. Grind or replace drum as appropriate

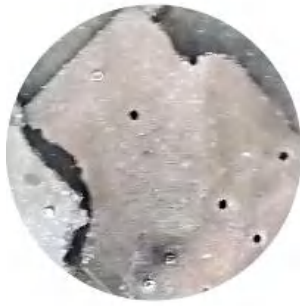
Burnt the lining

- Faults in brake mechanism
- Sticking brake shoes (weak return springs)
- Excessive use of brakes from high speed
- Wrong brake cylinders/air chambers or levers
- Overloaded vehicle
- Incorrect brake proportioning between tractor/trailer units

- Lining wear out quickly
- Vehicle pull and excessive brake noise
- Deceleration too low

Replace linings, avoid overworking brakes and ensure brake components are correct and are in good condition

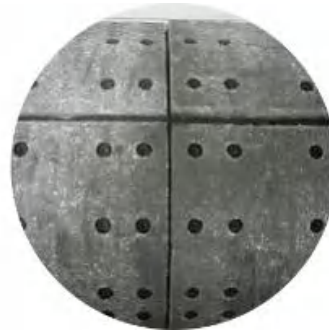
Cracking on the surface of brake lining

Caused by excessive brake temperature, i.e. when brake is cold on motorway then having to perform a sudden stop i.e. off a slip road. Rapid temperature input does not allow for heat soak from material into brake system

- This condition has no effect on the integrity or performance of the lining
- Penetration of the crazing is usually no more than 1mm deep
- Wear through with normal brake use and
- has no effect on the lining

Avoid high-speed heavy duty braking from cold

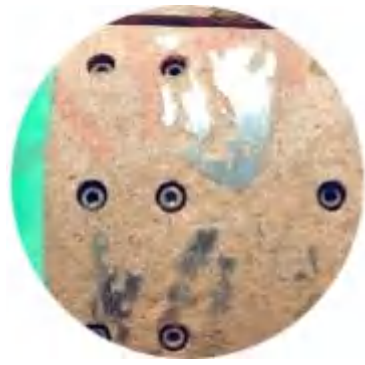
Dirt on the brake lining surface

- Poor drum condition, e.g. heat crazing
- Wrongly adjusted or worn axle bearings

- Lining wear out quickly
- Squeal and noise
- If linings not 100% bedded-in, low brake efficiency can result

- Replace linings, replace wheel bearing and replace or grind drum as appropriate
- Avoid overheating brake

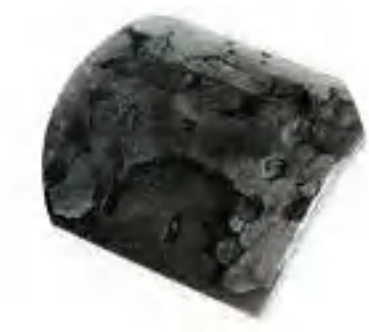
Dirt on the brake lining surface

- Faults in brake mechanism
- Sticking brake shoes (weak return springs)
- Excessive use of brakes at high speed
- Overloaded vehicle
- Too large air chambers

- Lining wear out quickly
- Vehicle pull and excessive brake noise
- Disintegration of lining
- Low deceleration

Replace linings, avoid overworking brakes and ensure brake components are correct and are in good condition

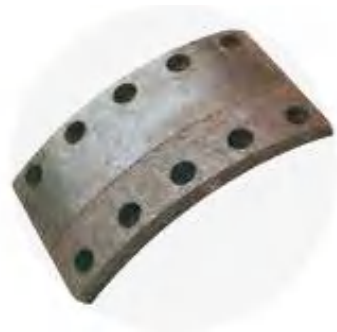
Step on the brake lining surface

- There may be a step in the brake drum surface
- General drum wear

- Rapid lining wear
- If the wear pattern differs across the axle, vehicle pull and excessive noise can result

Grind/Machine drum surface or renew (a drum grind may incur oversize lining fitment)
